Snow and Ice Removal in a Rocky Mountain Municipality

Stucchi's Snow and Ice Removal Solutions

MAINTENANCE OF SNOW PLOWS IN HIGH SALT ENVIRONMENT

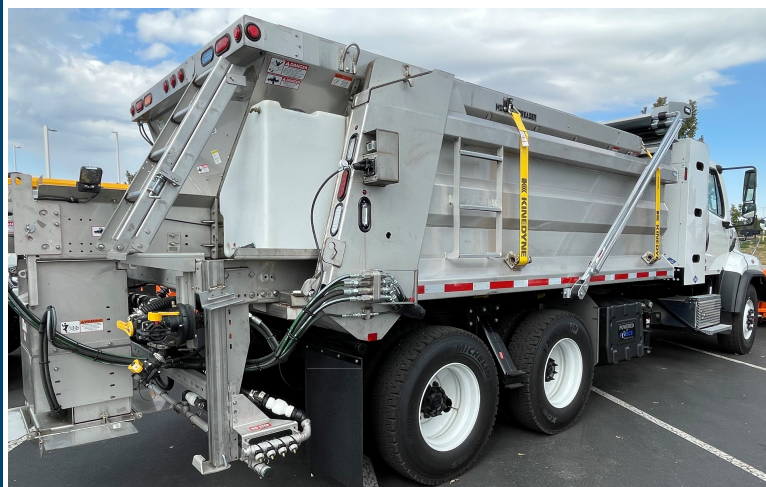
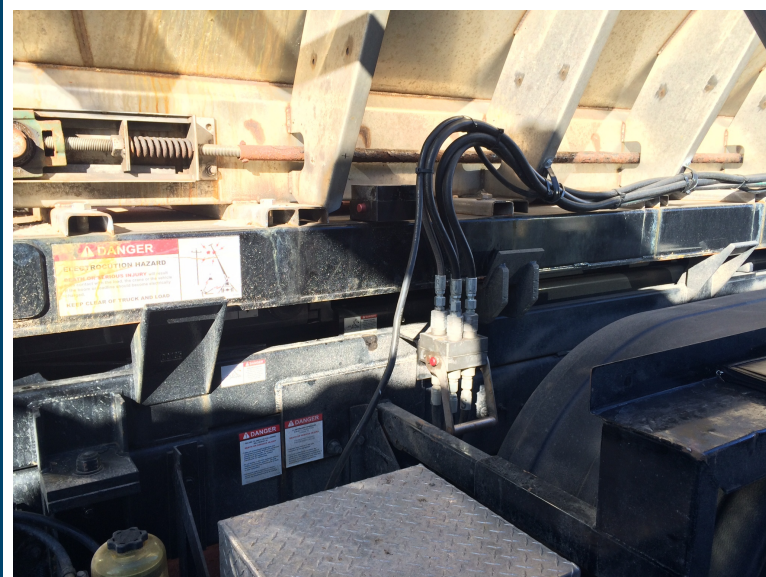
Stucchi's couplings prevent leaking on disconnection, although prior to our adaptation to stainless steel, the cap on the multi-plates would lock in place when disconnecting due to the exorbitant amount of salt used in this region.

Due to the large amount of salt used in this region to combat snow and ice accumulation, the plates in the front from another hydraulic supplier would lock up with corrosion during the change in seasons, and the couplings would leak upon quick disconnect and become damaged due to pressure energizing the O-rings. Costly challenges included:

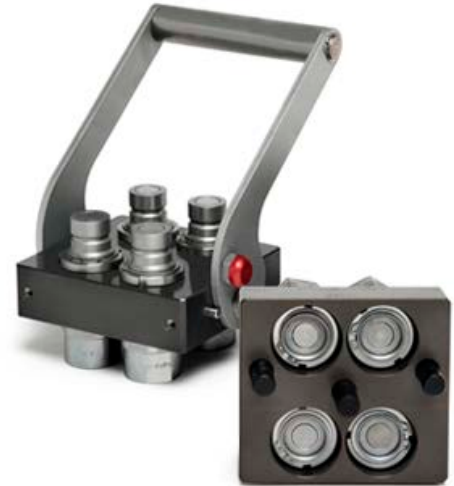
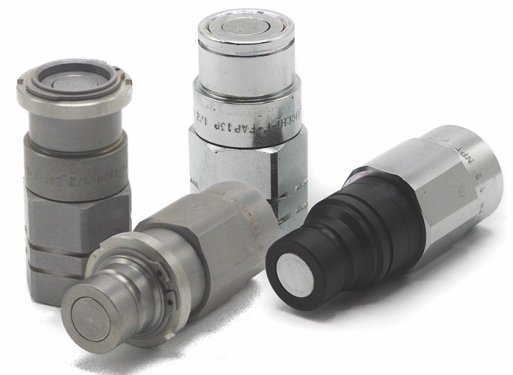
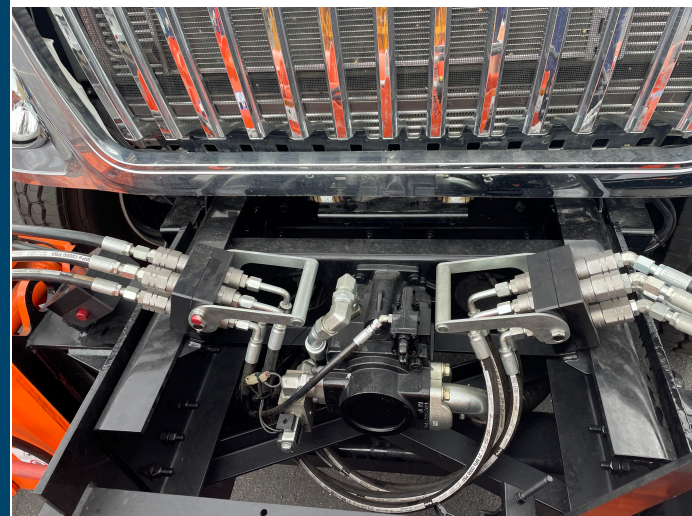
- DP multi-coupling plate with stainless steel components
- FAP flat face quick couplings to connect under pressure with no leakage or damage

Stucchi addressed this issue by adapting all multi-coupling plates to stainless steel with our integrated flat face couplers, designed to easily connect and disconnect under residual pressure with no fluid spillage.
